TECHNICAL INSPECTION REPORT

OPERATION CROSSROADS. U.S.S. SKIPJACK (SS184).
TEST BAKER, VOLUME 2[U].

Bureau of Ships Group technical inspection rept.,

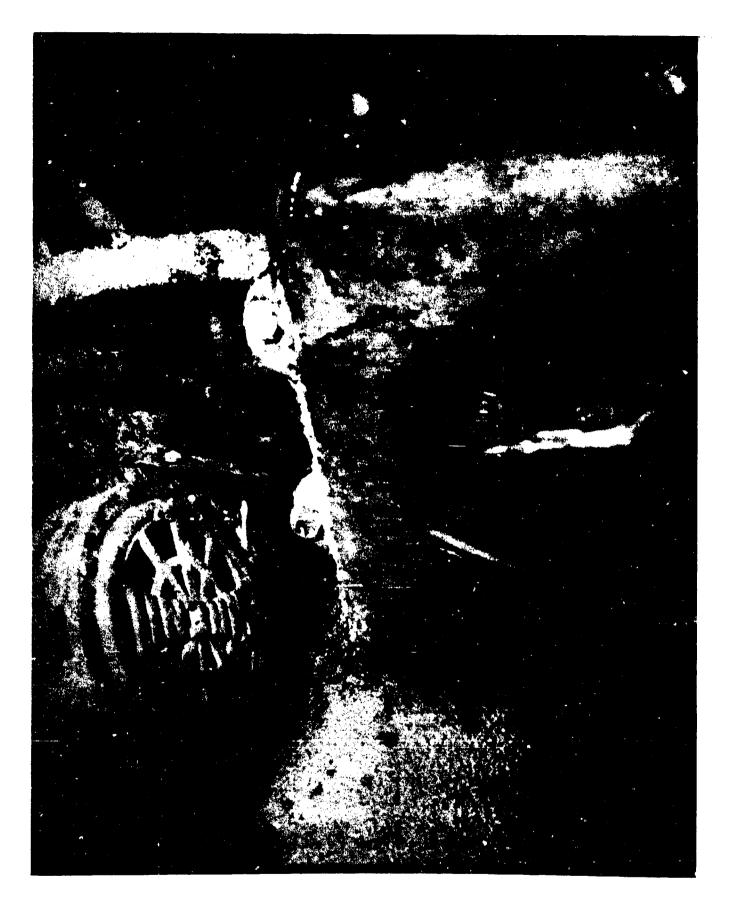
AB-CR-MIG-6513-8. Control cubicle port side front top foundation action bolt.

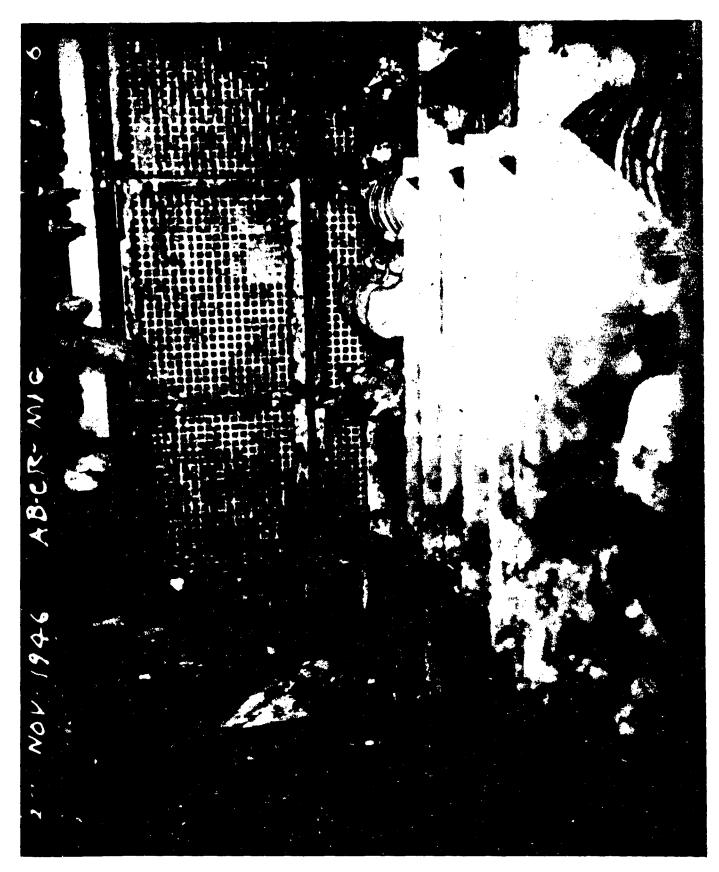
AB-CR-MIG-6514-6. Propulsion control cubicle port & starboard motor starter contactors.

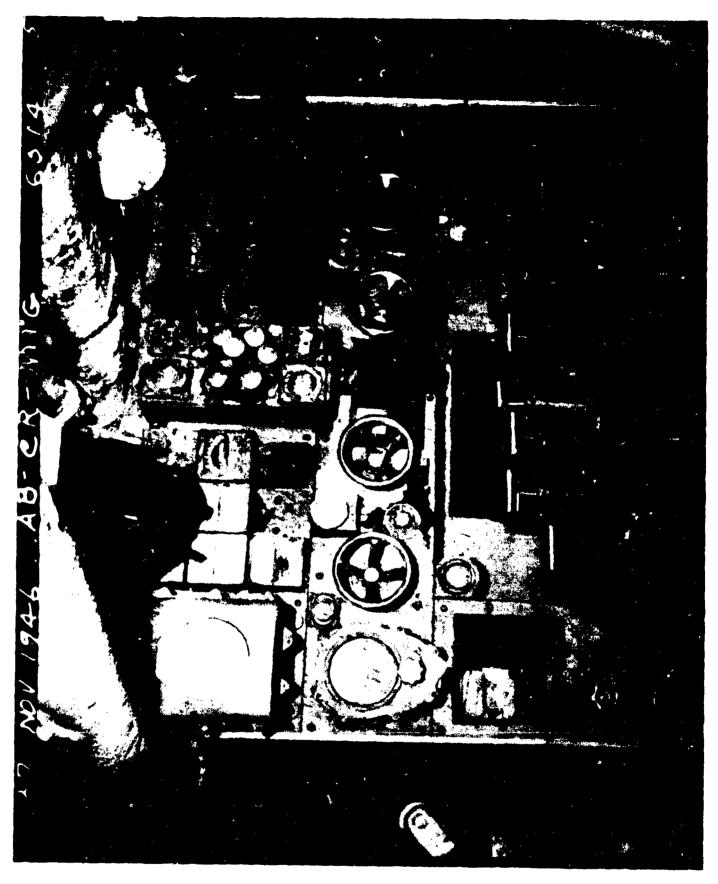
AB-CR-MIG-6514-5. Propulsion control cubicle.

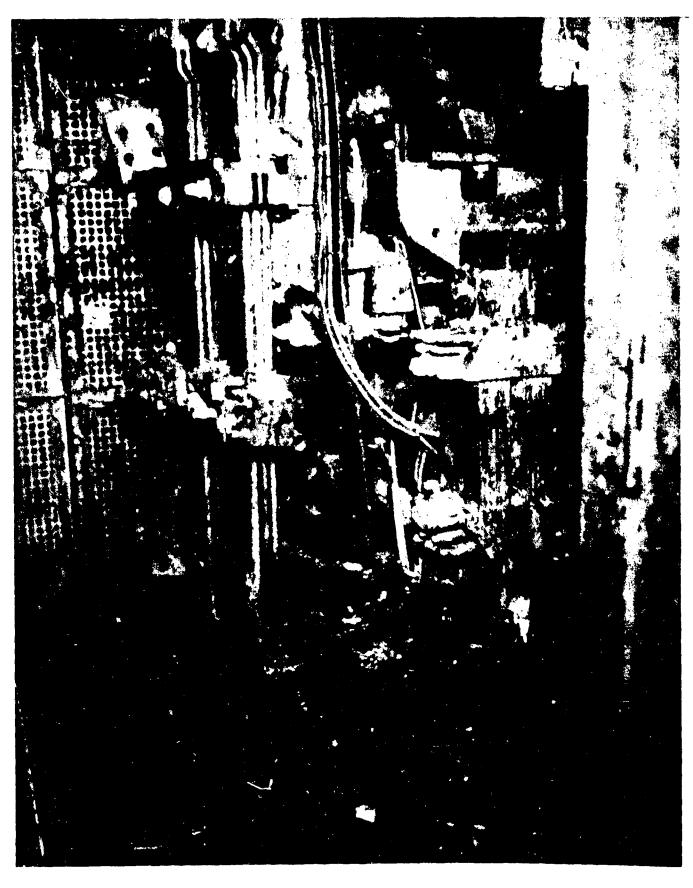
AB-CR-MIG-6514-7. Propulsion control cubicle Shunt and bussing for #2 propulsion generator.

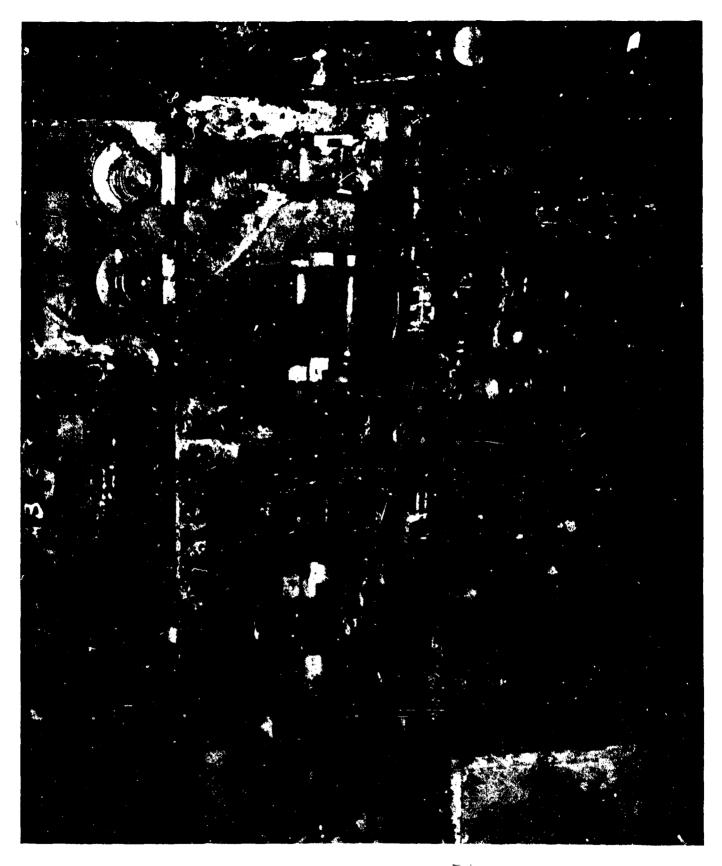
AB-CR-MIG-6514-3. Auxiliary power switchboard.

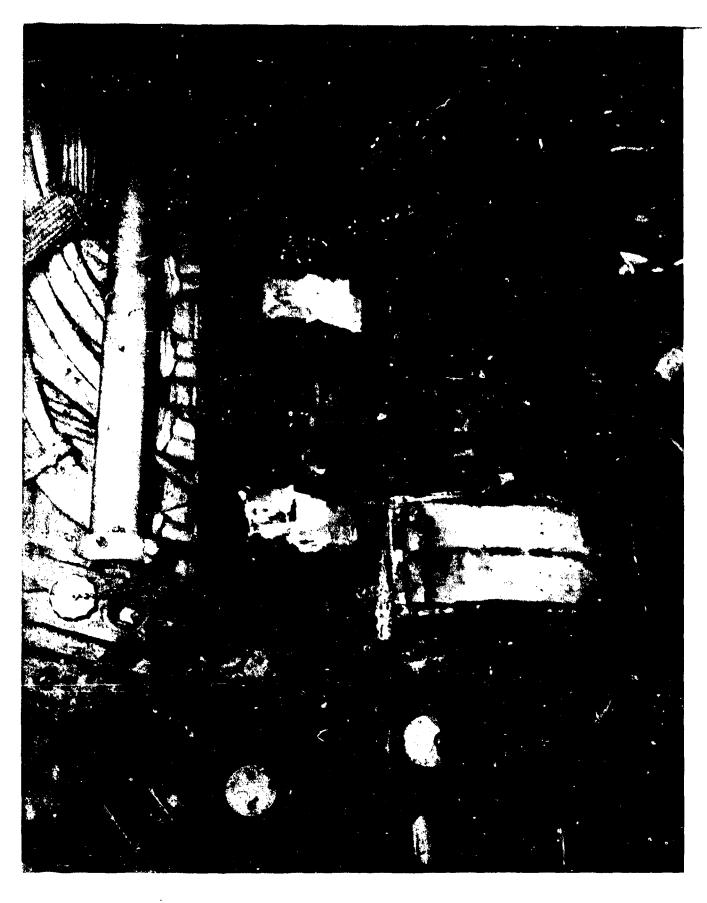
AB-CR-MIG-6514-4. Forward auxiliary power switchboard.

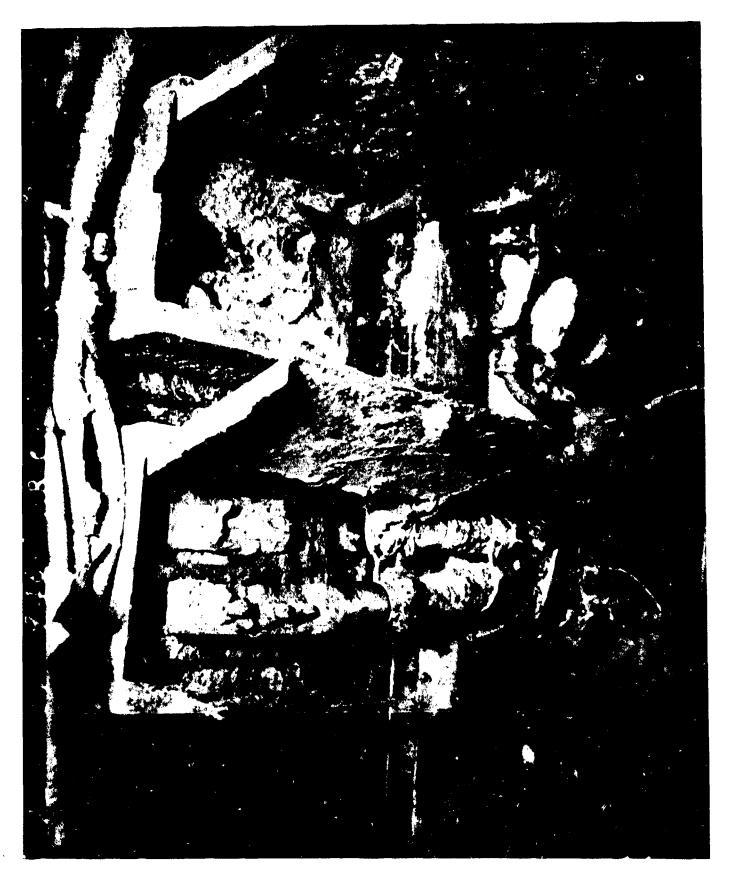
AB-CR-MIG-6511-6. Auxiliary power shore connection boxes.

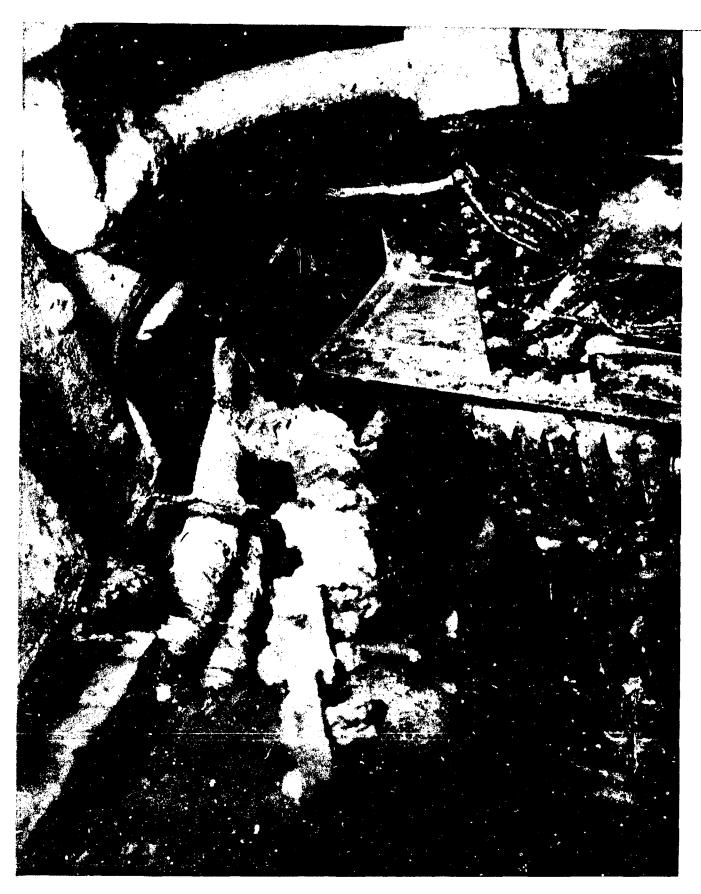
AB-CR-MIG-6511-7. Auxiliary power shore connection boxes.

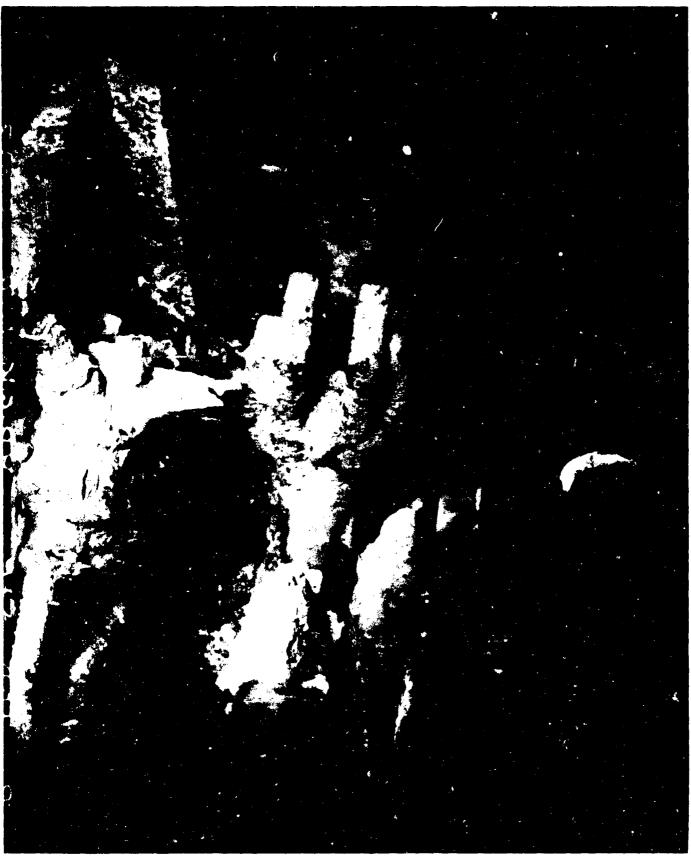
AB-CR-MIG-6513-1. "Minus" Disconnect switch-forward battery.

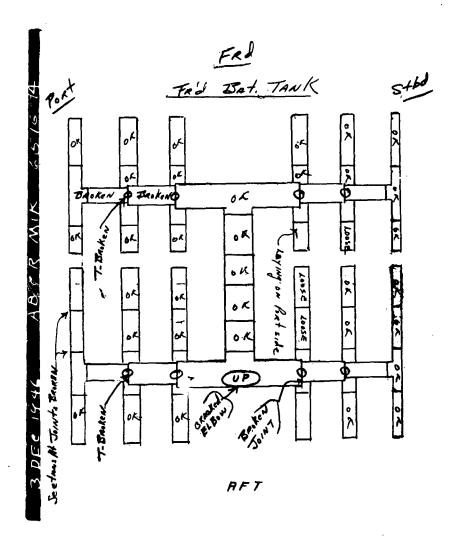
AB-CR-MIK-6516-14. Sketch of forward battery vent duct arrangement and damage.

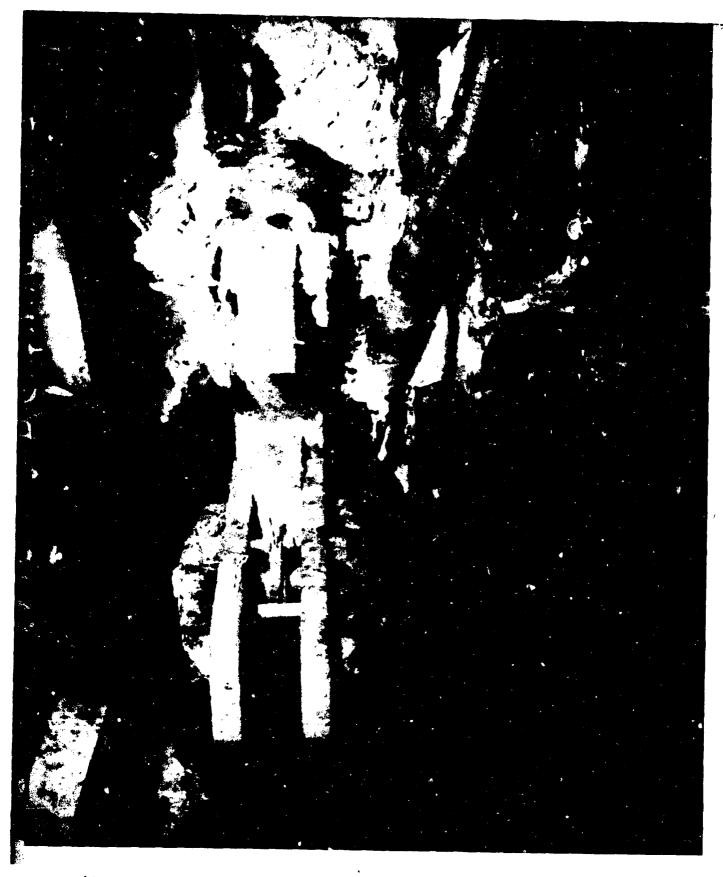
AB-CR-MIG-6513-2. "Plus" Disconnect switch-forwart battery.

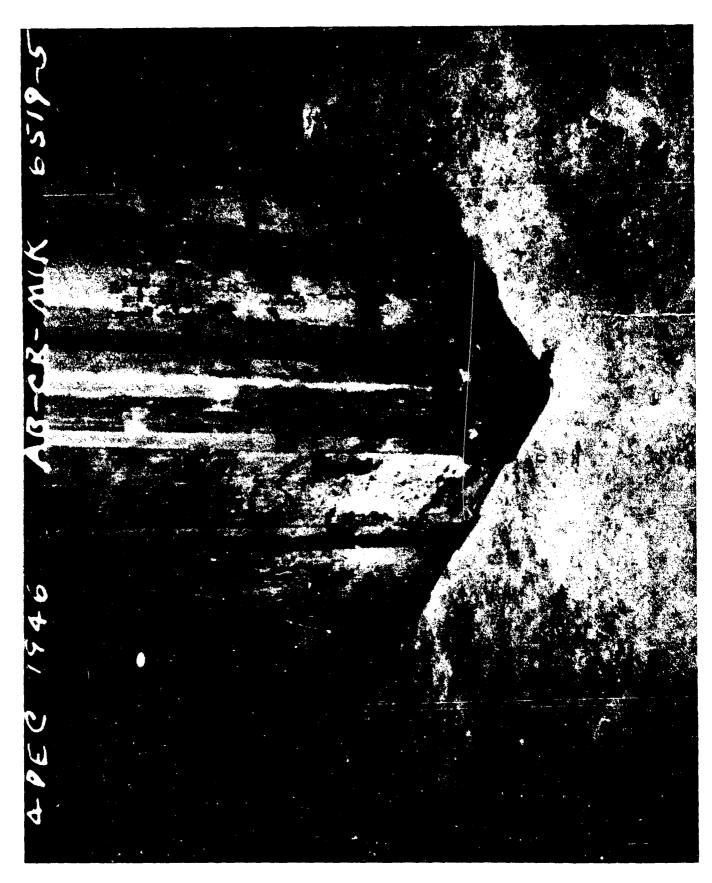
AB-CR-MIK-6519-5. After battery - cracks in #34 cell case.

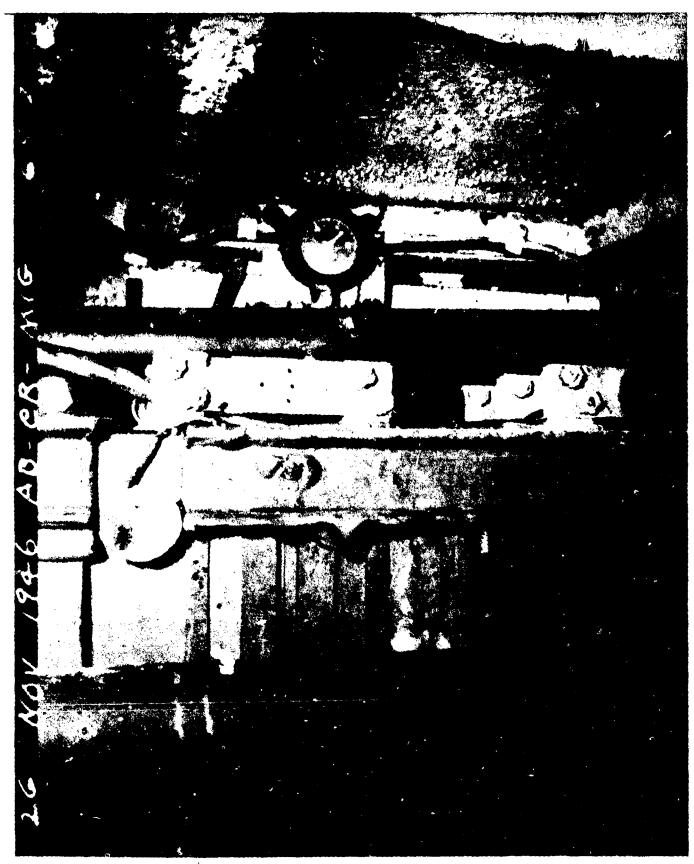
AB-CR-MIG-6512-10. Intercoll connector after battery.

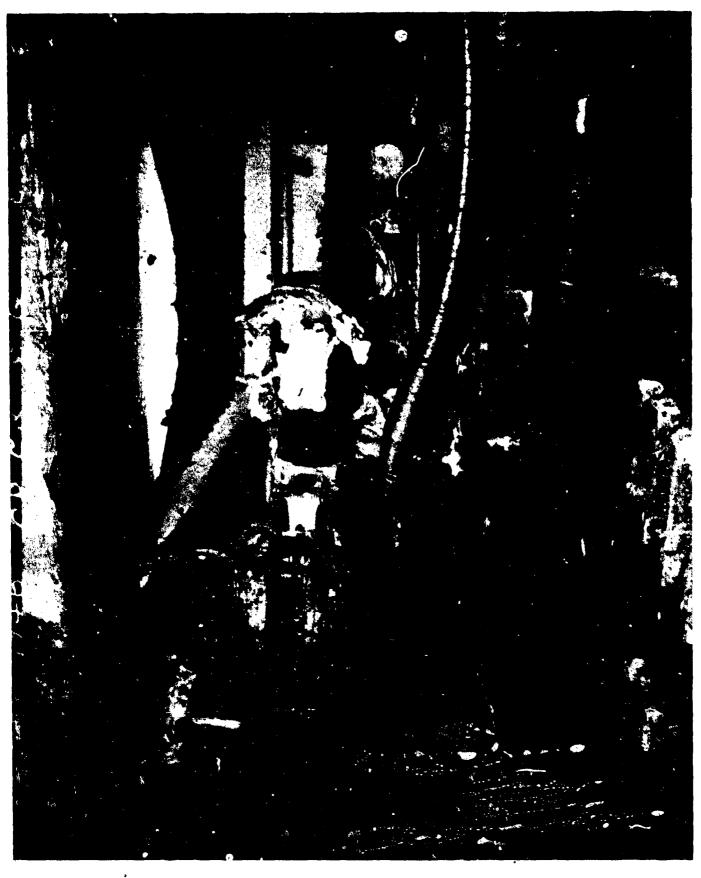
AB-CR-MIG-6512-8. After battery "plus" disconnect switch.

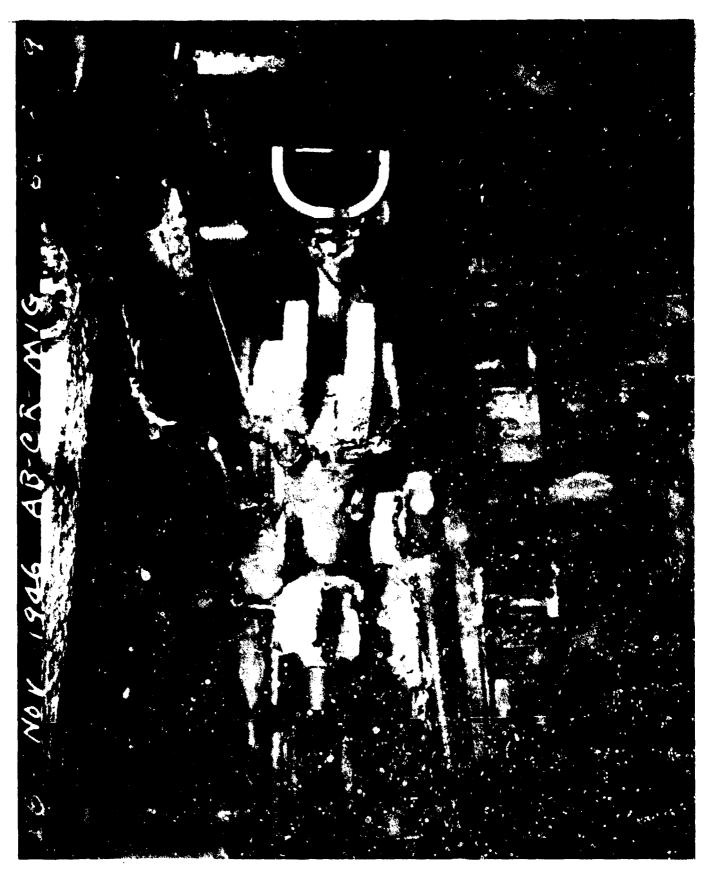
AB-CR-MIG-6512-9. After battery "minus" disconnect switch.

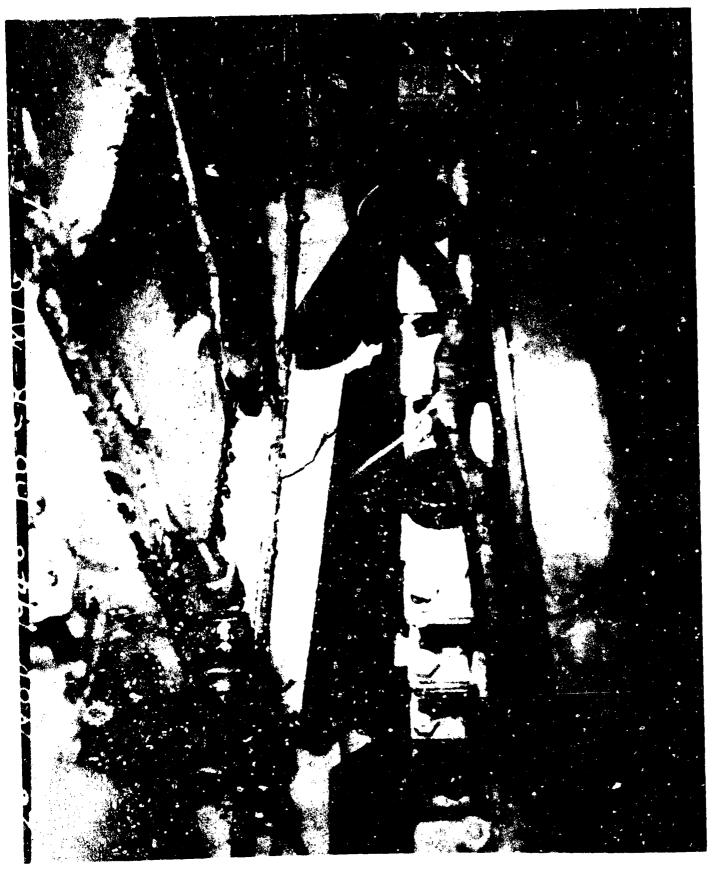
AB-CR-MIG-6512-11. Ventilation port side - after battery.

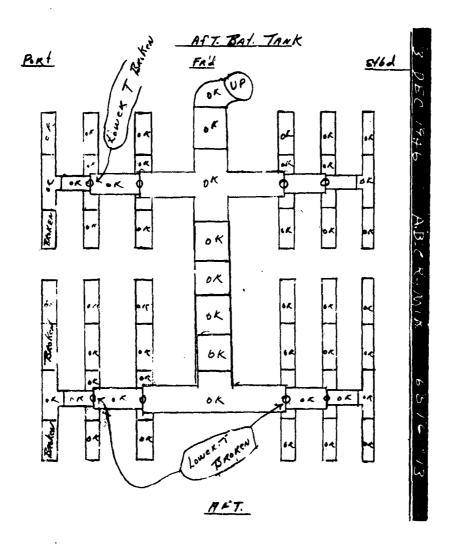
AB-CR-MIK-6516-13. Sketch of after Battery vent duct arrangement and damage.

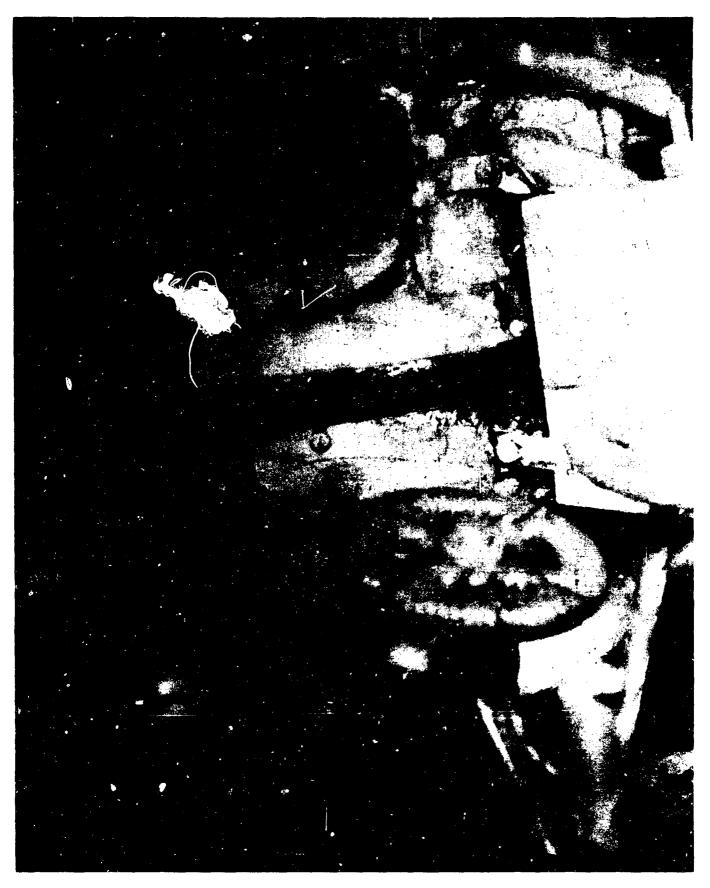
AB-CR-MIG-6506-10. Bow plane rigging and capstan motor.

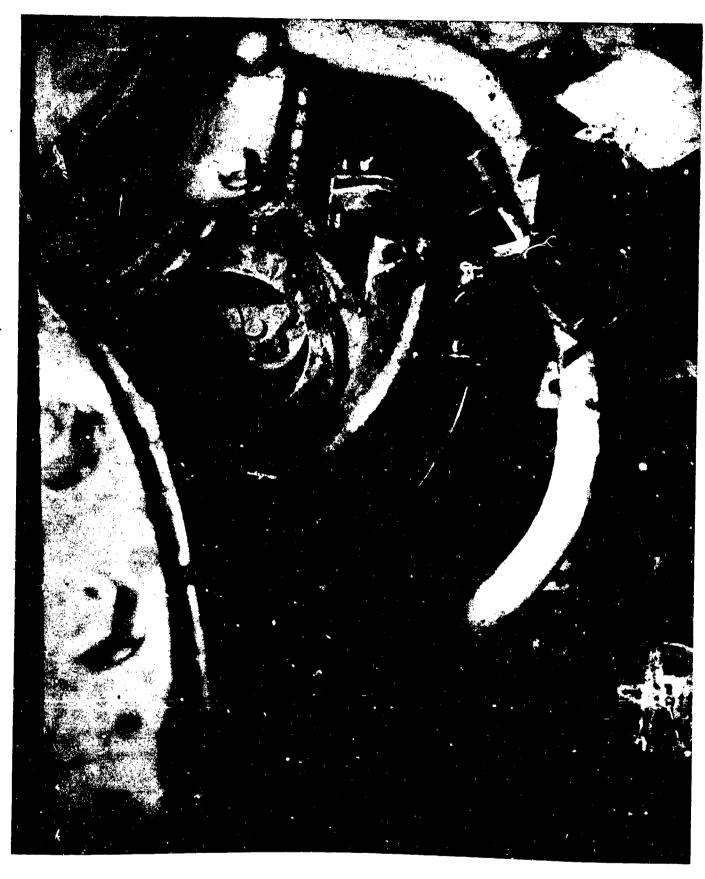
AB-CR-MIG-6512-4. Bow plane rigging motor brush rigging.

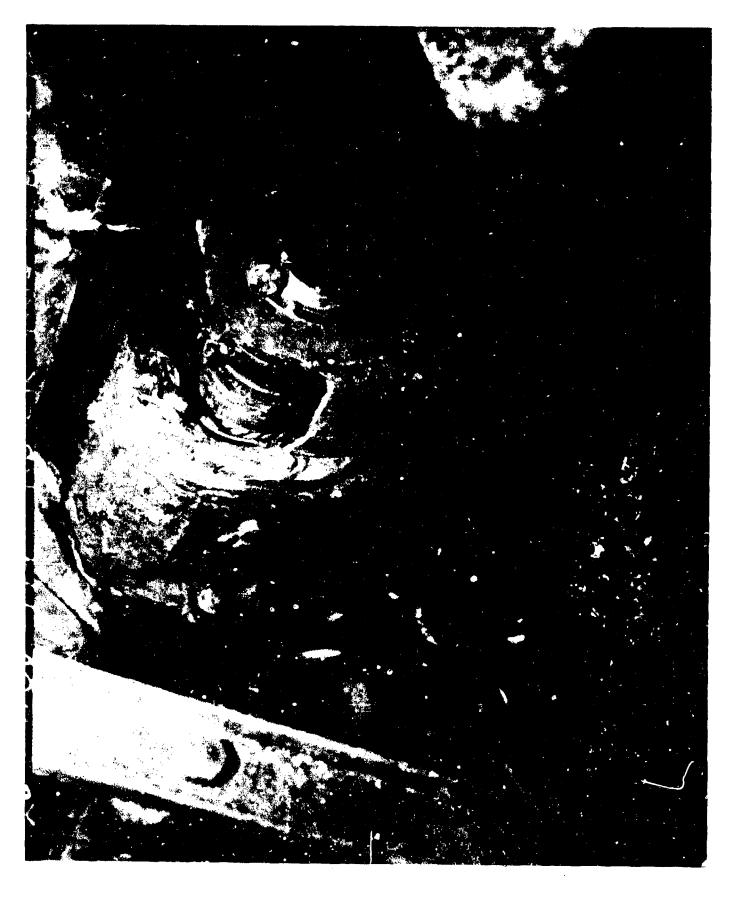
AB-CR-MIG-6512-12. #1 Lubricating and fuel oil transfer pump motor.

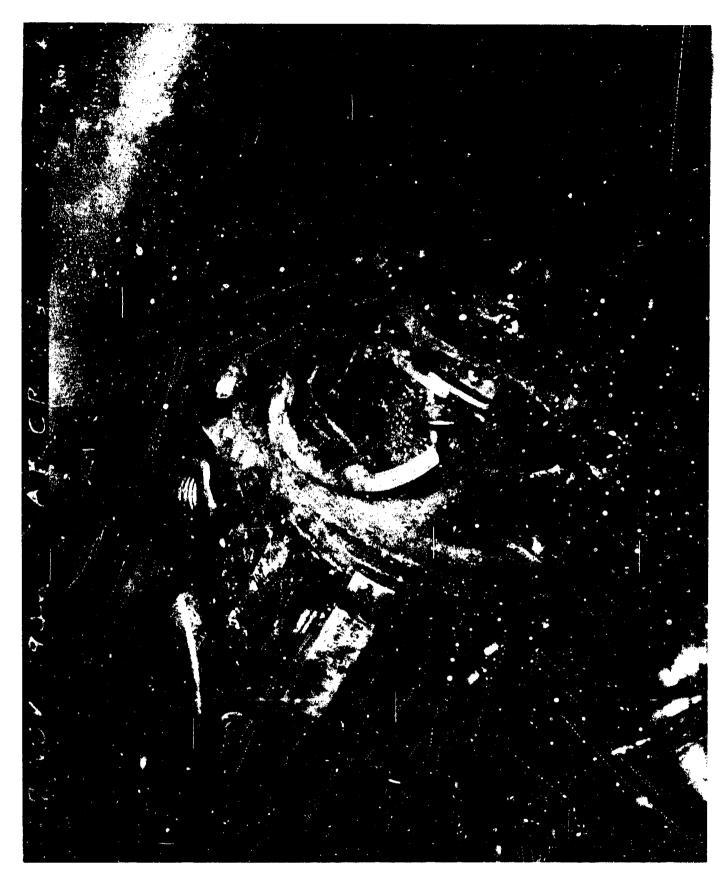
AB-CR-MIG-6514-8. #2 Lubricating oil purifier pump motor.

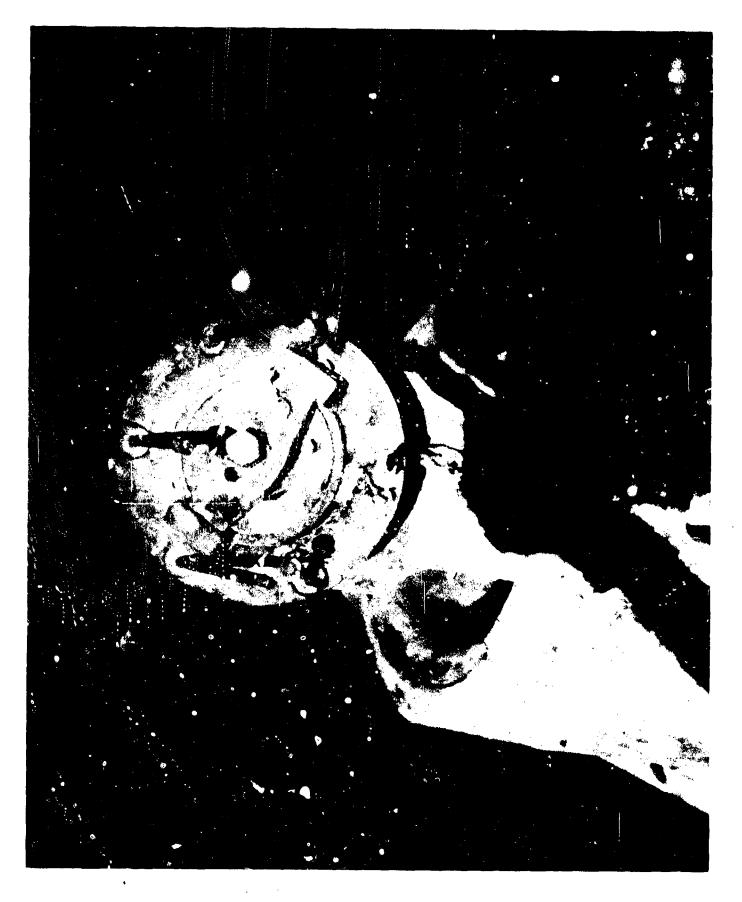
AB-CR-SM-6501-4 Forward anchor light from aft.

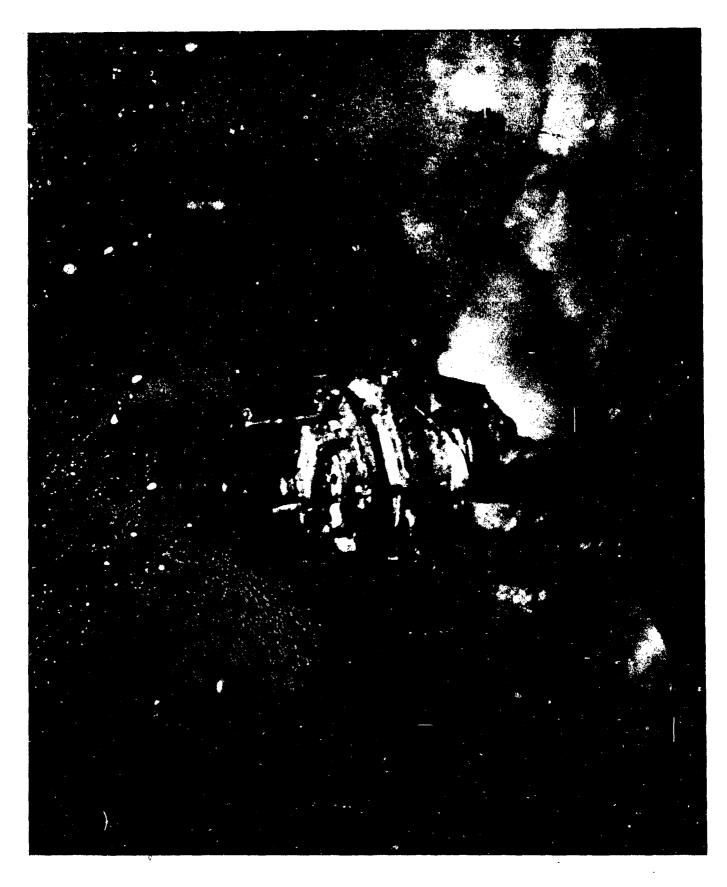
AB-CR-SM-6501-5. Forward anchor light from deck level.

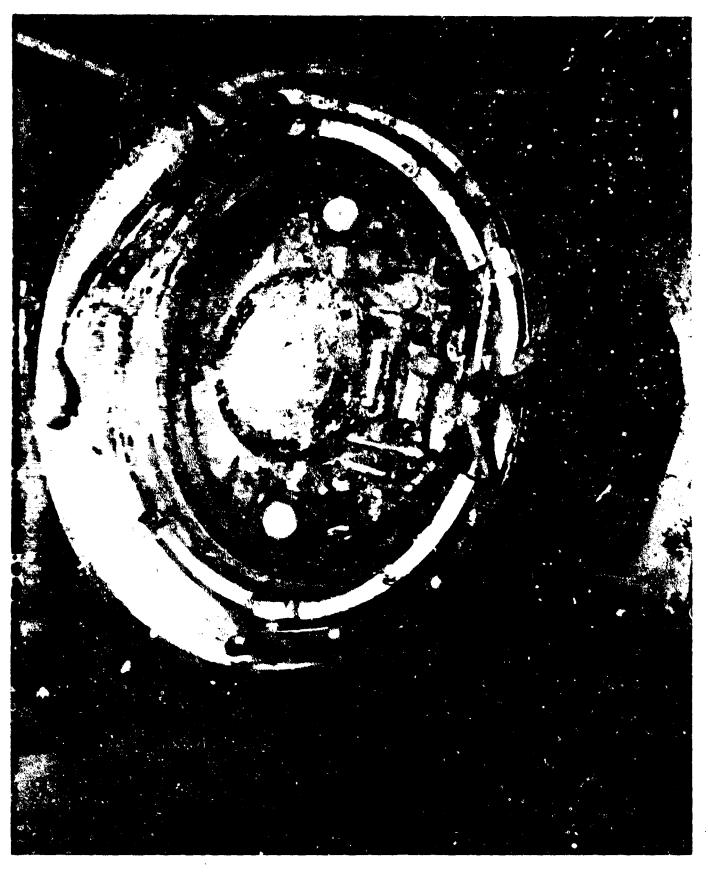
AB-CR-MIG-6511-2. Mark 7 Mod. 0 #7003 gyro compass.

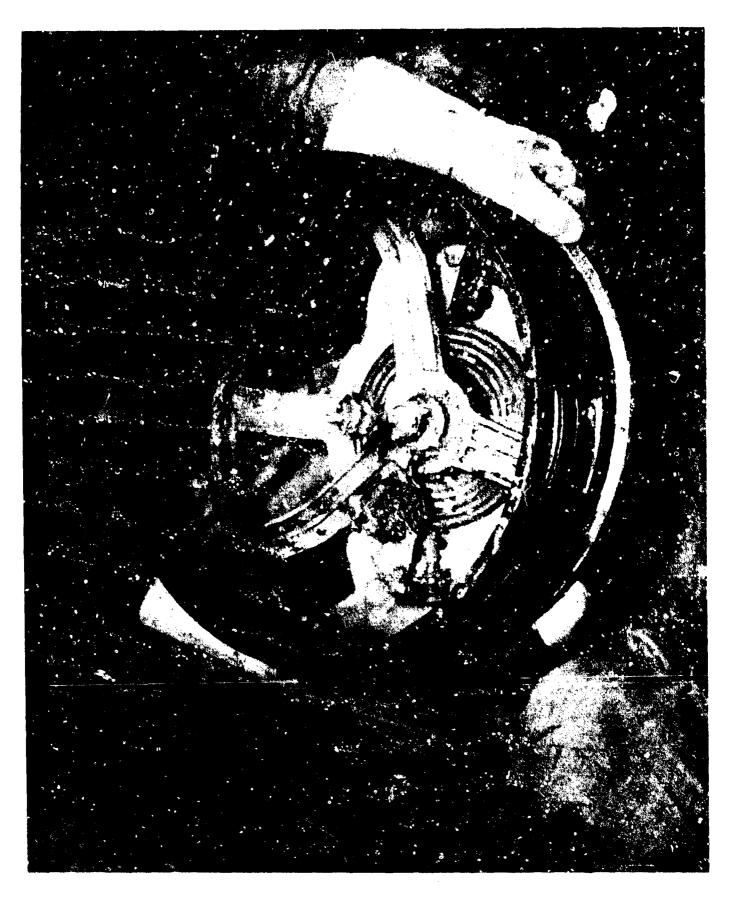
AB-CR-MIG-6511-3. Mark 7 Mcd. 0 #7003 gyro compass.

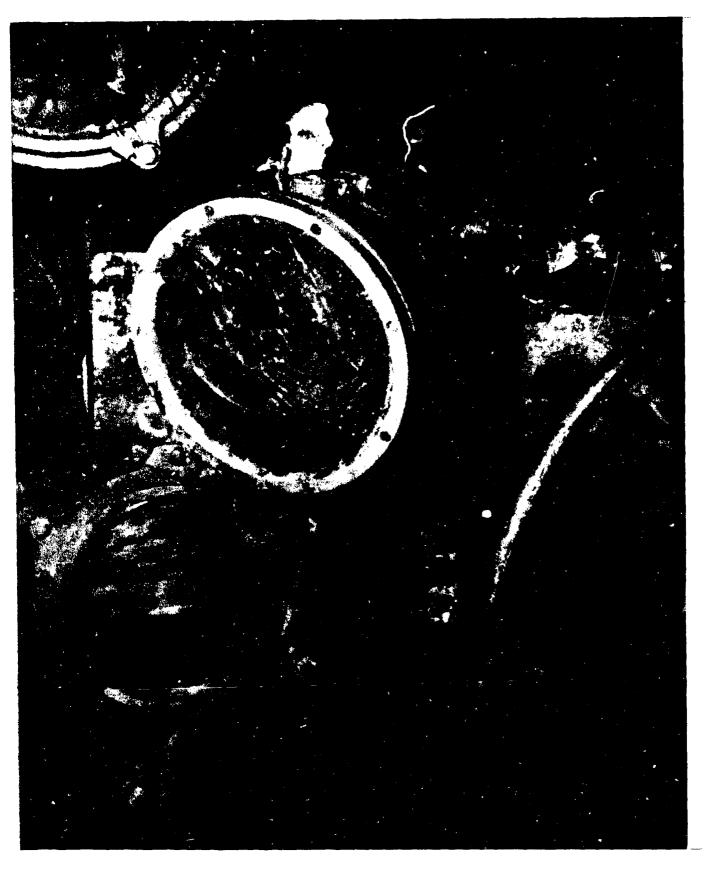
AB-CR-MIG-6524-9. Conning tower gyro repeater.

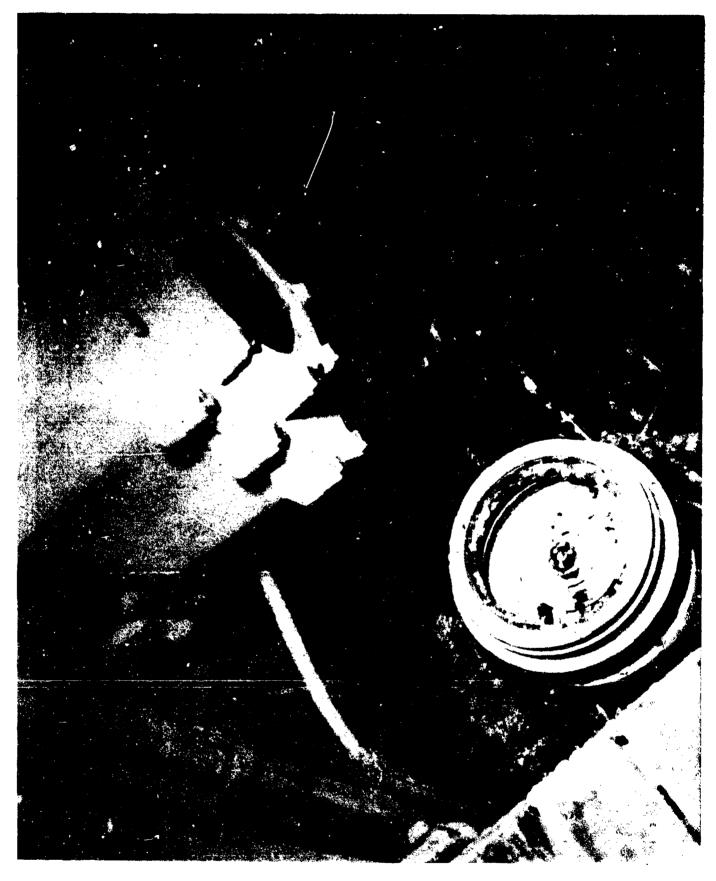
AB-CR-SM-6501-12. Bridge gyro repeater.

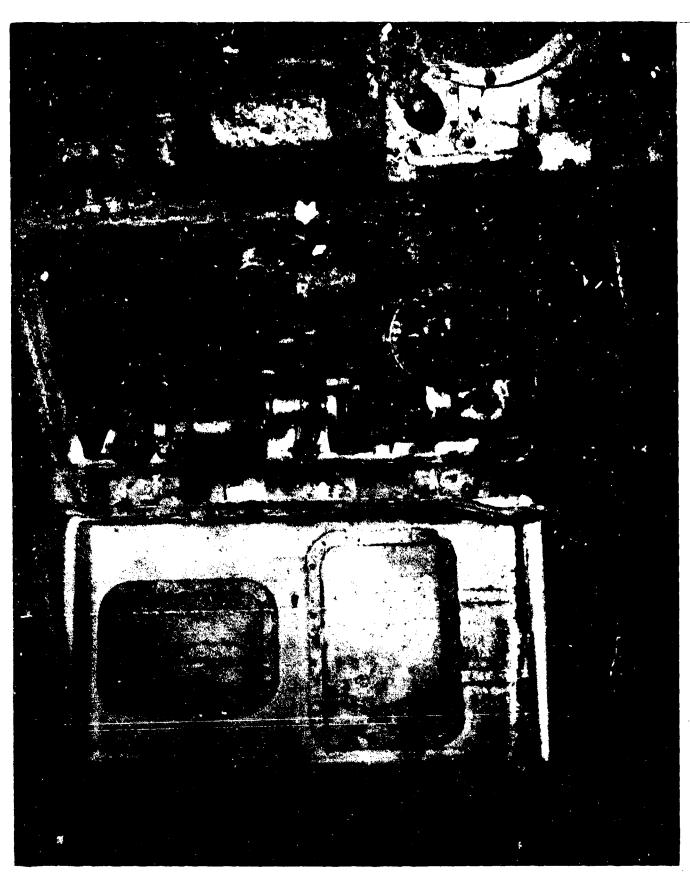
AB-CR-MIG-6511-12. D.R.A.indicator.

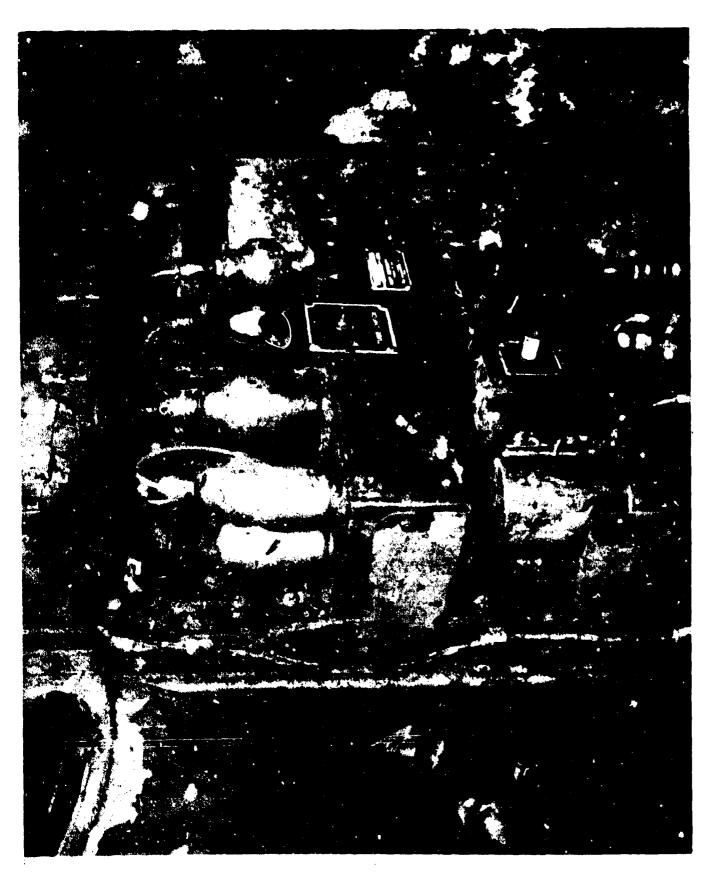
AB-CR-MIG-6511-11. 1 M.C. Power amplifier #1.

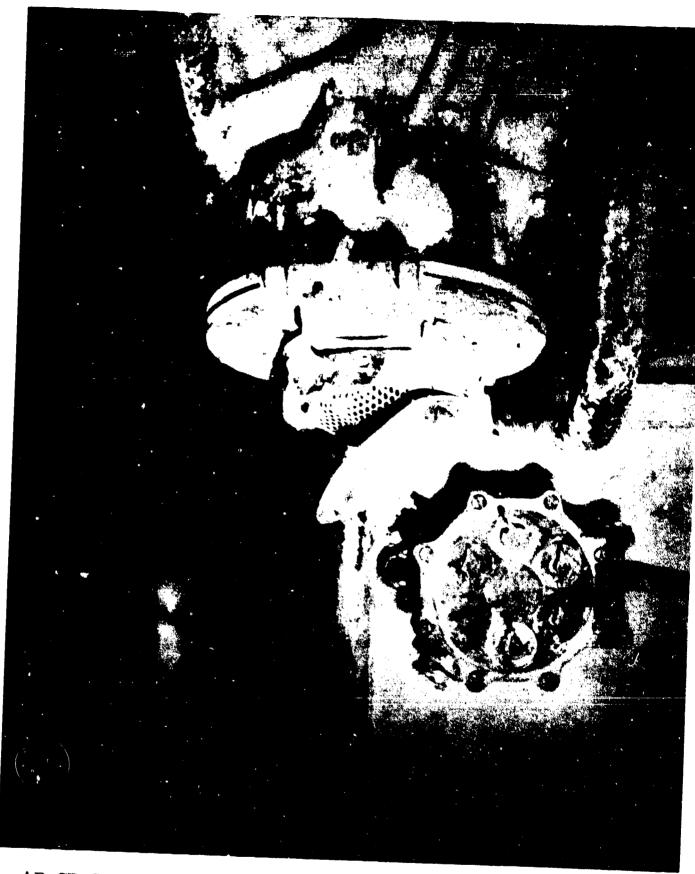
AB-CR-SM-6501-8. Forward bridge pressure proof speaker and selector panel.

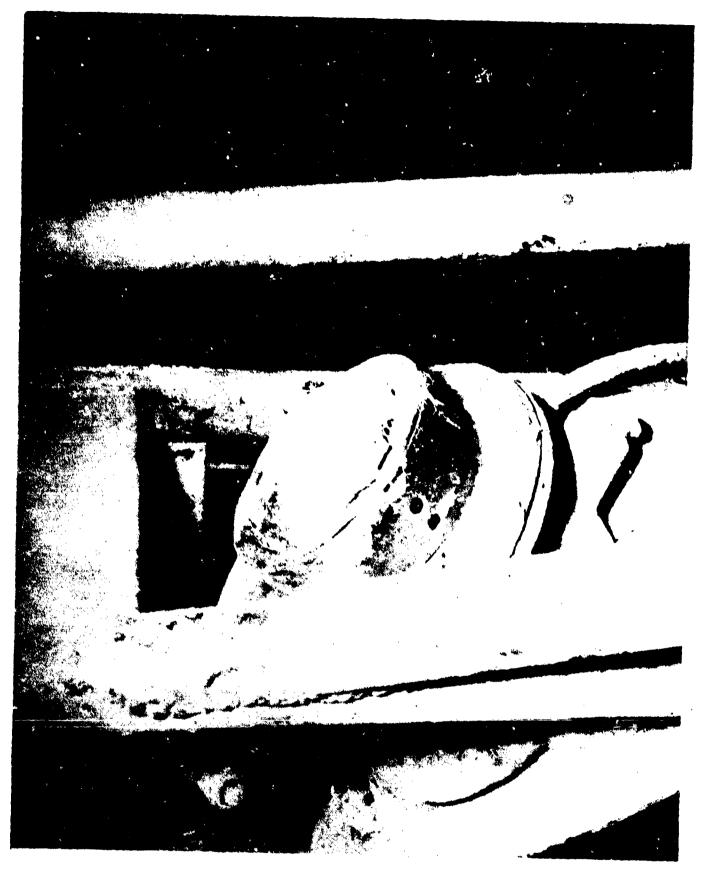
AB-CR-SM-6501-7. After bridge pressure proof speaker..

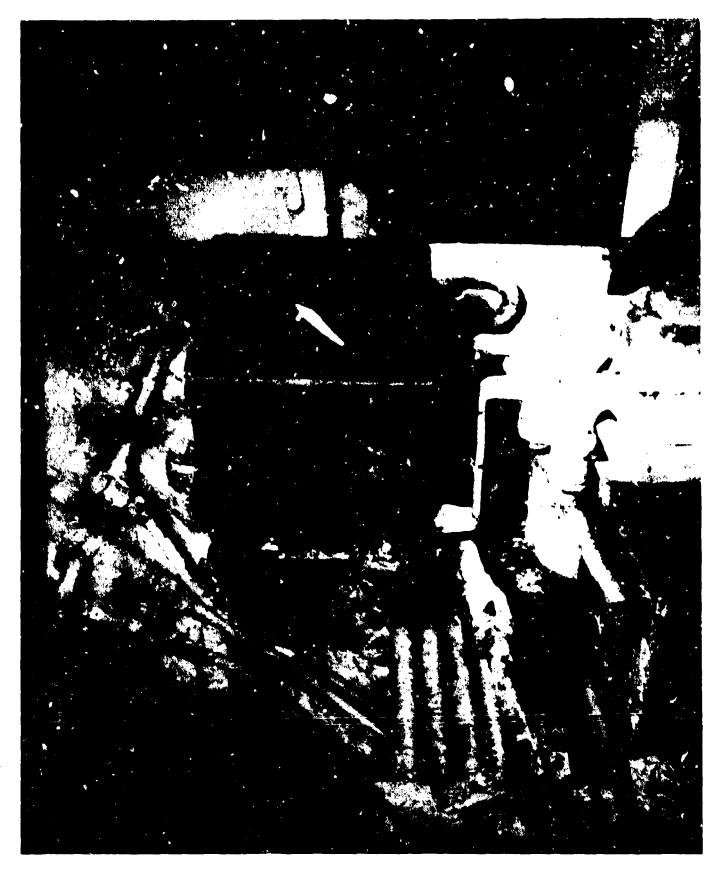
AB-CR-MIG-6511-10. Control room bow plane indicator.
